# Alternative Bank Protection Methods for Puget Sound Shorelines

# **Alternative Bank Protection Methods for Puget Sound Shorelines**

Shorelands and Environmental Assistance Program  
Washington Department of Ecology  
Olympia, Washington

Publication # 00-06-012

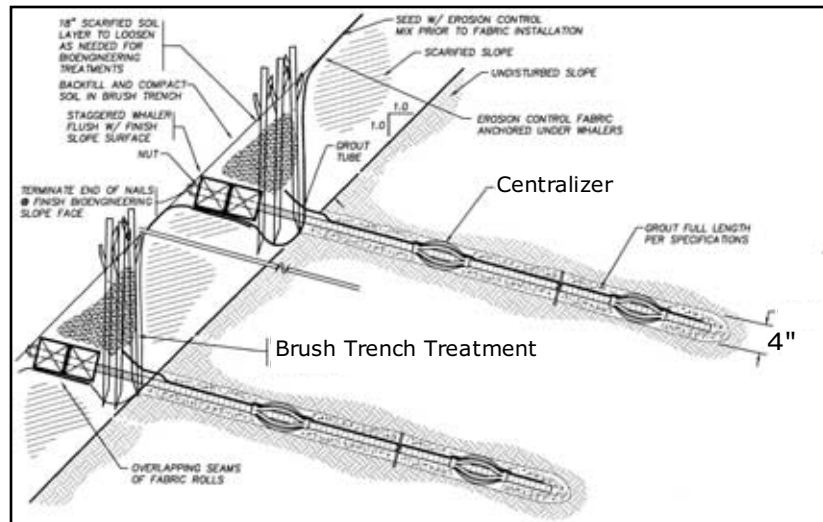
Detail: Soil Nailing

Soil nailing is the process of running re-bar into the slope to help hold it together. Holes were drilled back into the slope using a drill rig lowered down the bluff from a boom truck. These holes were 4" in diameter and ranged from 15-32' deep. The nails are epoxy-coated re-bar with "centralizers" (4" donut-like spacers) placed every few feet to keep the nails in the

middle of the hole. When the nails were all in place, the holes were filled by pumping in "grout". This consisted of Portland cement with some added sand. The grout bonds the nails to the earth. About 48

The soils on the site were glacially compacted and the slope is failing in blocks. Soil nails prevent this. At the face of the bluff each nail has a zone of support about 6-8' in diameter. The amount of support decreases deeper into the slope. Similarly, the slope is under the greatest pressure to fail at the face and becomes less stressed at depth. Nails are placed so that their areas of support overlap or touch at the slope surface (6' on center). The upper portion of the slope was secured using the following method.

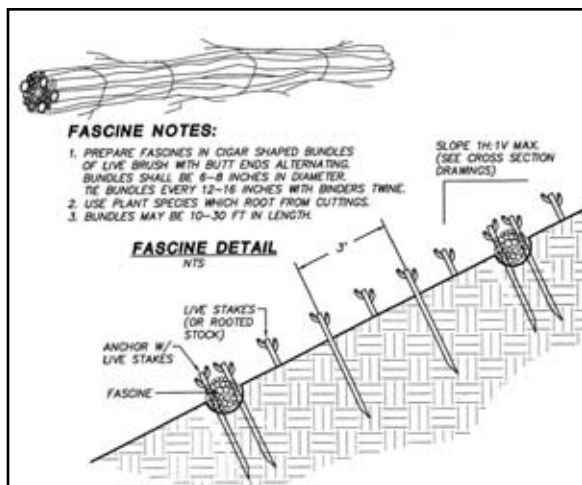
Detail: Brush Trench

a) “Windrow” trenches or “Brush” trenches. These reinforce the surface and shallow mantle. Shallow trenches were cut bluff for every 6’ of elevation. "Cigar" bundles (8"x 30') of rootable whips (Hooker, Scouler & Sitka willows) were in the trenched. These will grow into the and their root systems will provide substantial support.

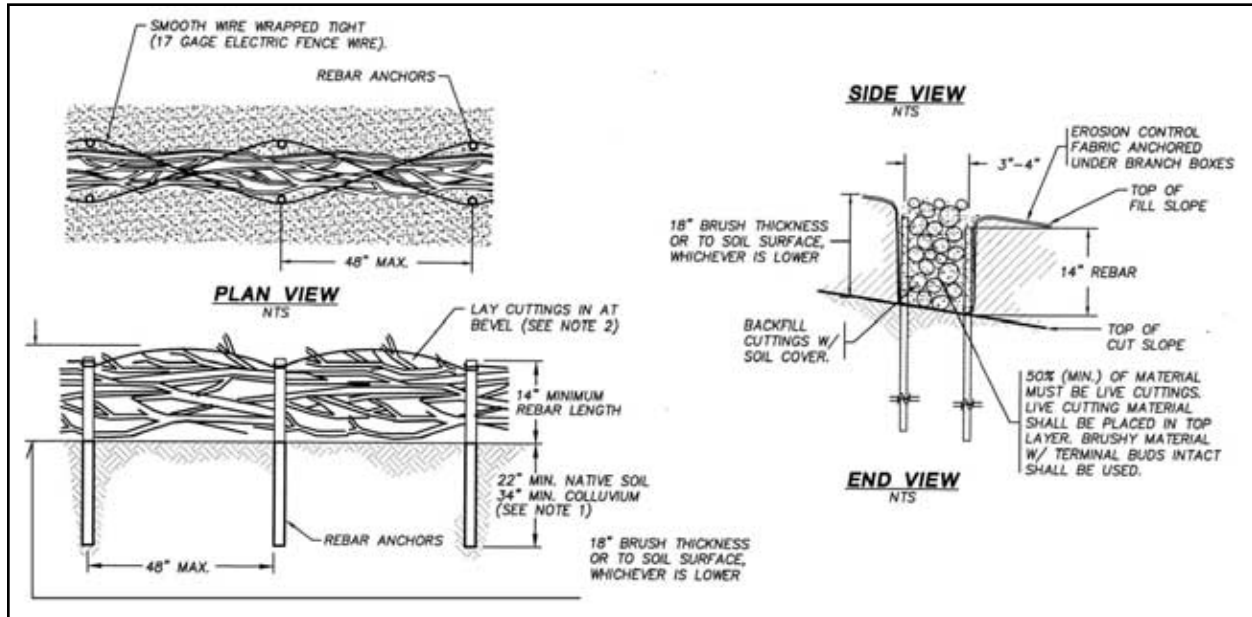
Detail: Branch Boxes

The whole slope was covered with the coir. This material will provide support and protection during the vegetation establishment period and will rot out in about three years. This third phase was completed in the spring of 1999 and the entire slope was growing vigorously by the first week in September 1999. A temporary irrigation system was installed that will be taken down after the first two growing seasons.

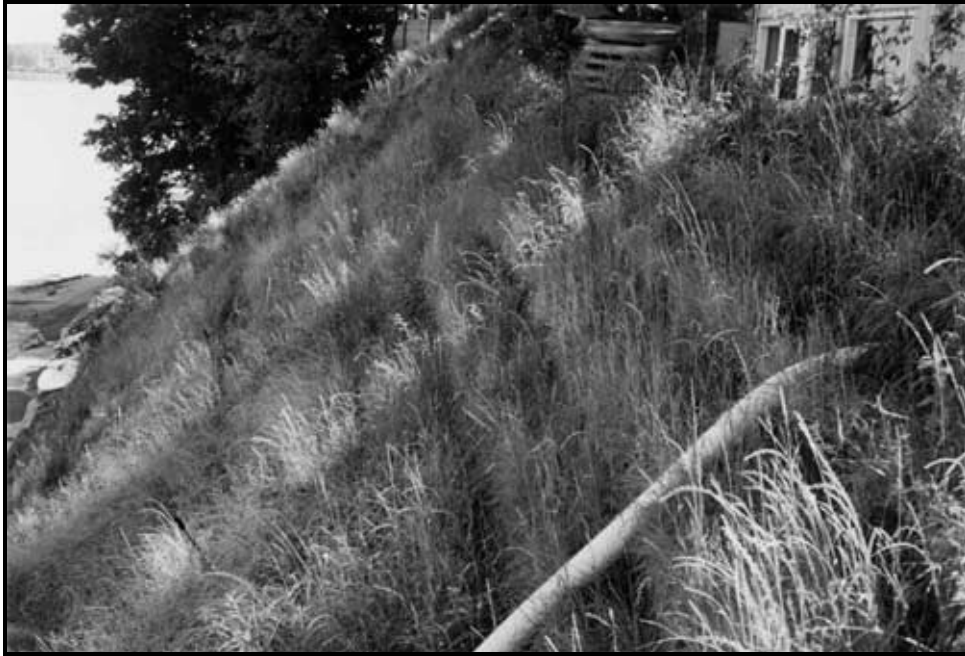
Figure 1. Vegetative slope stabilization. The bands of vegetation correspond to individual geogrid lifts. The hose in the foreground is part of new drainage system and flows into a diffuser behind the bulkhead.

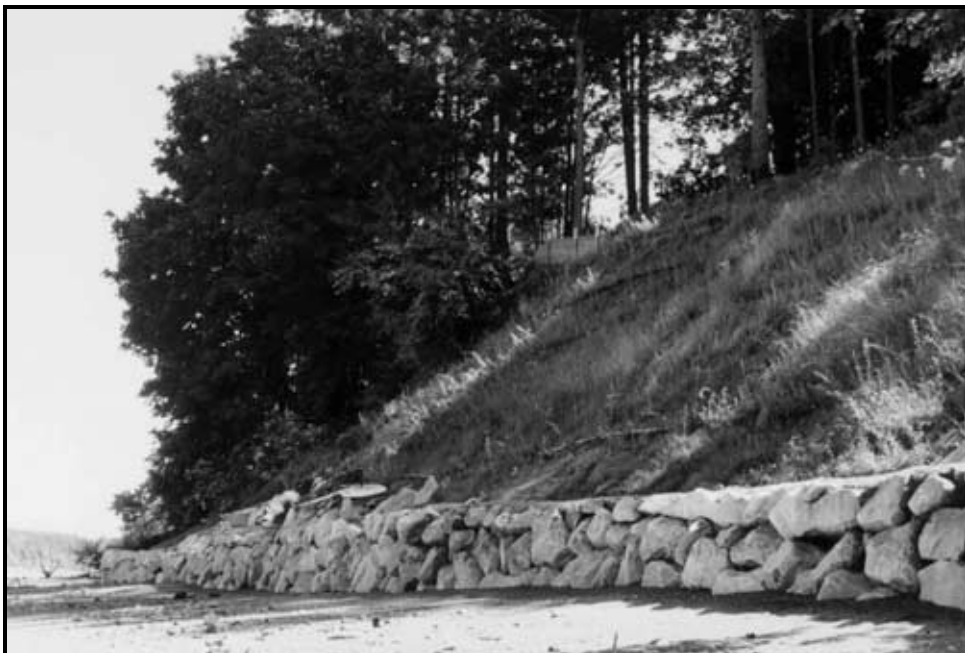
Figure 2. View from the beach. The lift layers can be seen. The slope is approximately 1H:1V, compared to its original near-vertical pre-construction state. The bluff is 30+ feet tall (the rock bulkhead is 5-6 feet high).

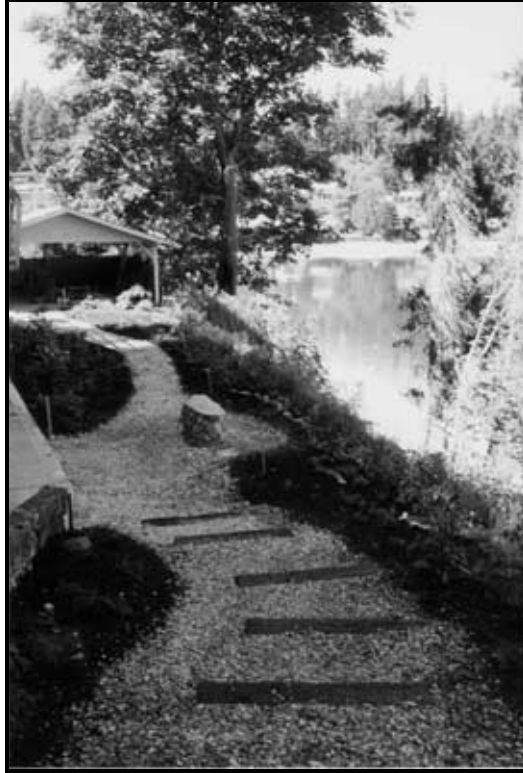
Figure 3. Path in front of house. Prior to construction this was part of the driveway, but narrowing the path allowed more room for laying back the slope.

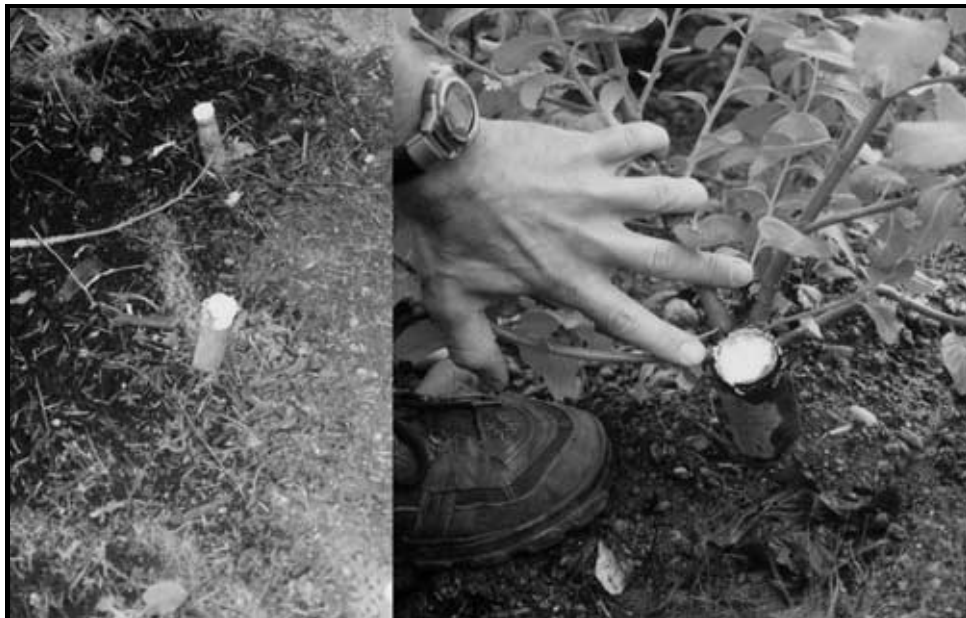
Figure 4. Live staking. When willow stakes are installed there is no growth - just a 1.5" portion of a 2-foot stake driven into the substrate. Four months later, vigorous growth has begun to secure soils in place.

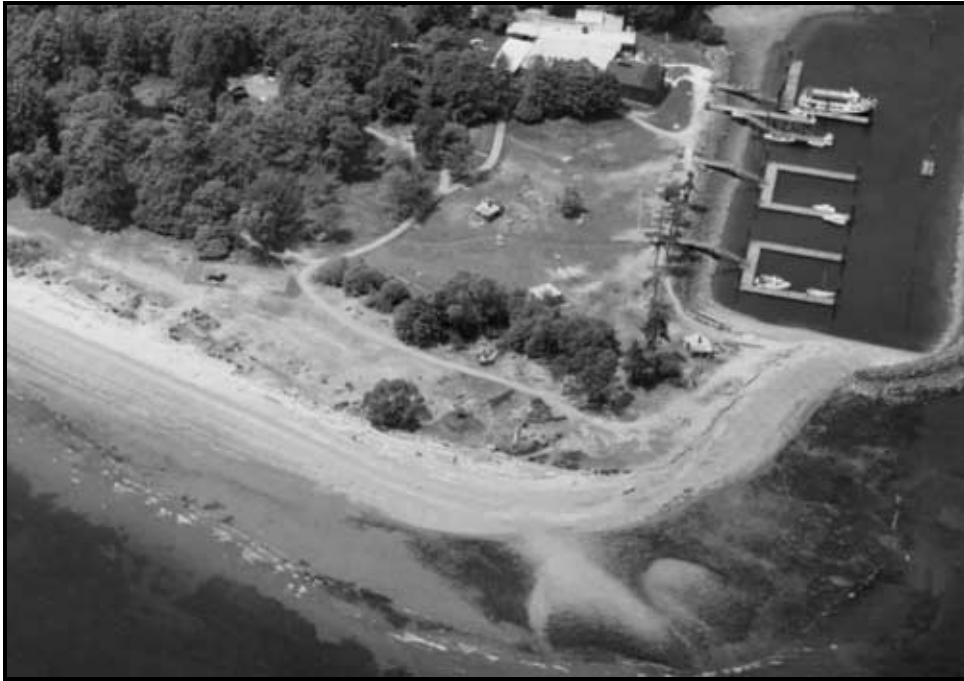
Figure 1. Aerial view of Blake Island site.  
*Photo: Ecology, KIT#707, 5-20-1992.*

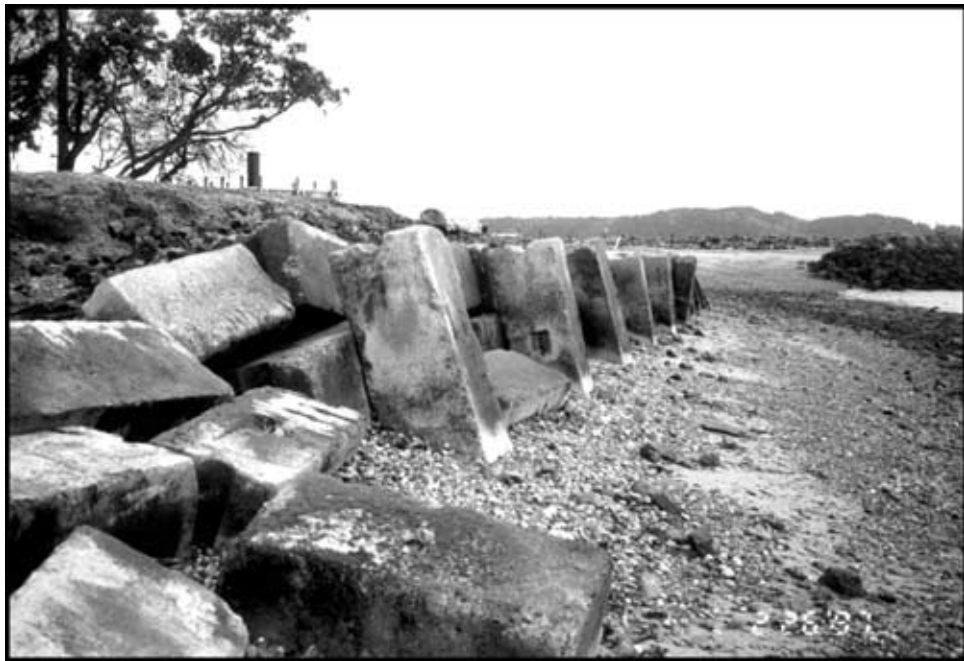
Figure 2. View northwest showing temporary "ecology block" erosion protection. Note significant damage done to temporary structure. Breakwater for boat basin is in background.

the modification of the point affected the movement of littoral drift from the south. Between the changes in littoral sediment supply and the placement of fine grained fill over the backshore and beach, erosion has been rapid. Following the severe northerly storms of late 1990, ecology blocks were placed as a temporary erosion control measure, but this structure has fared poorly and erosion has continued.

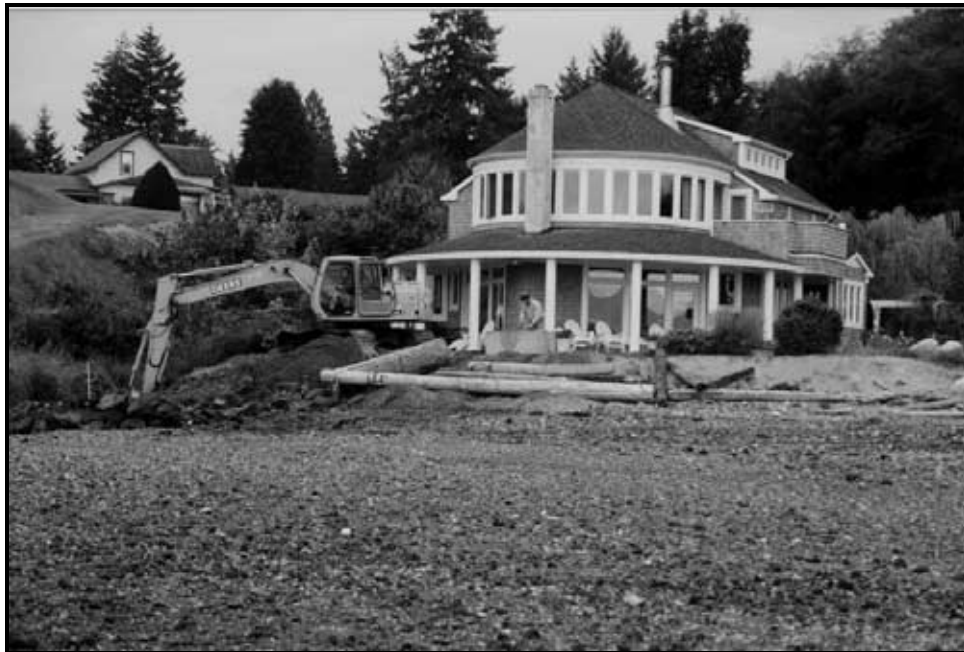
Figure 2. Construction. Note minimal setback and broad gravelly beach.

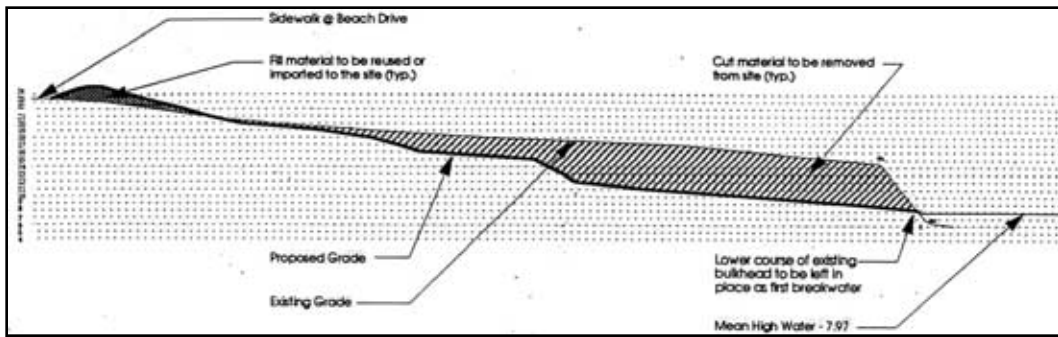
Typical Profile: North End.

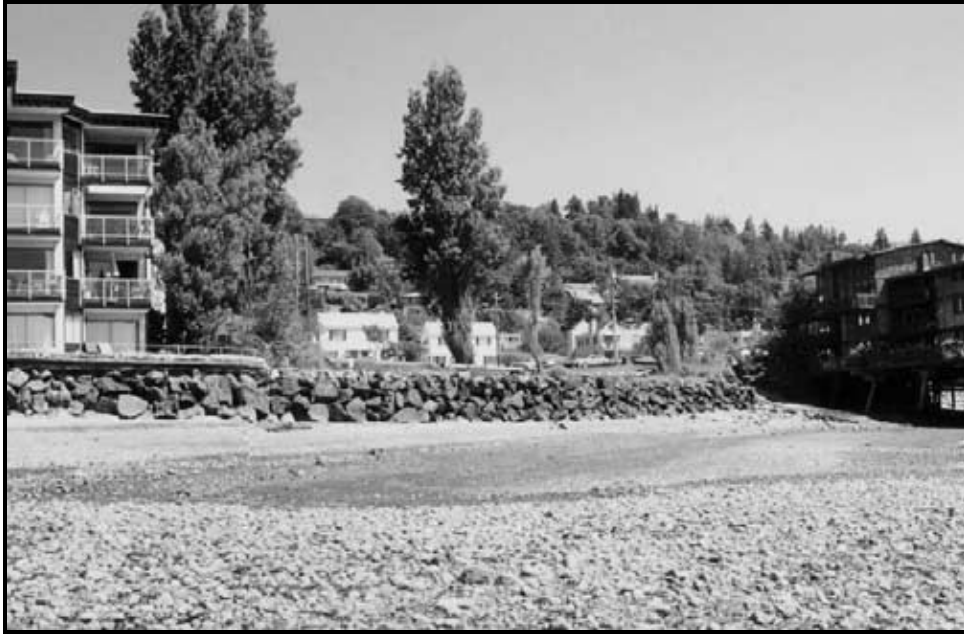
Figure 1. View of Cormorant Cove site from the beach at low tide. Much of the rock bulkhead will be removed when the project is constructed.

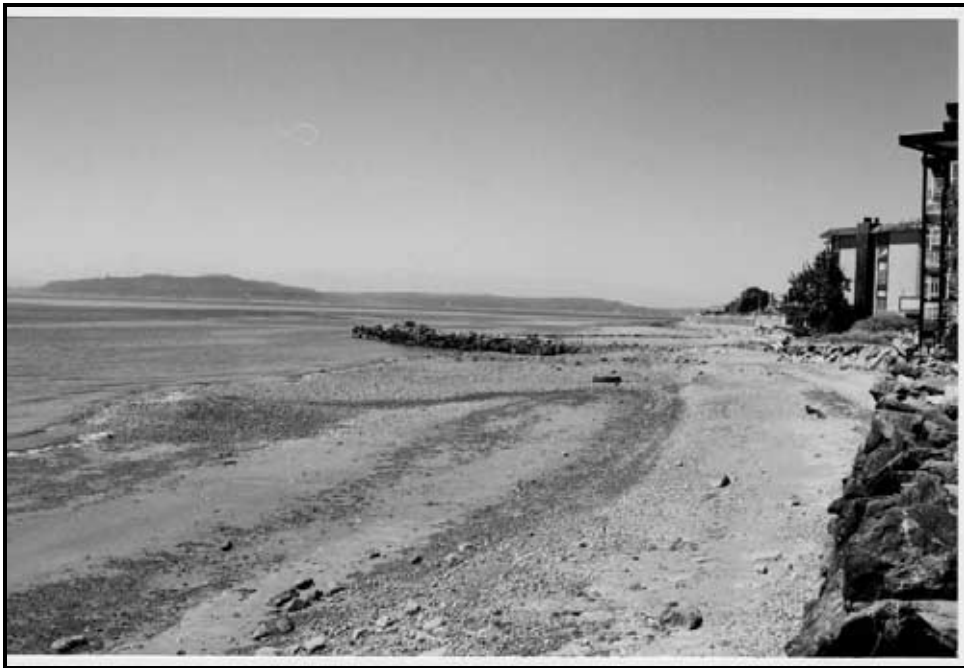
Figure 2. View to the north from 3701 Beach Drive, showing hardened shoreline and intrusion of bulkhead onto upper beach.

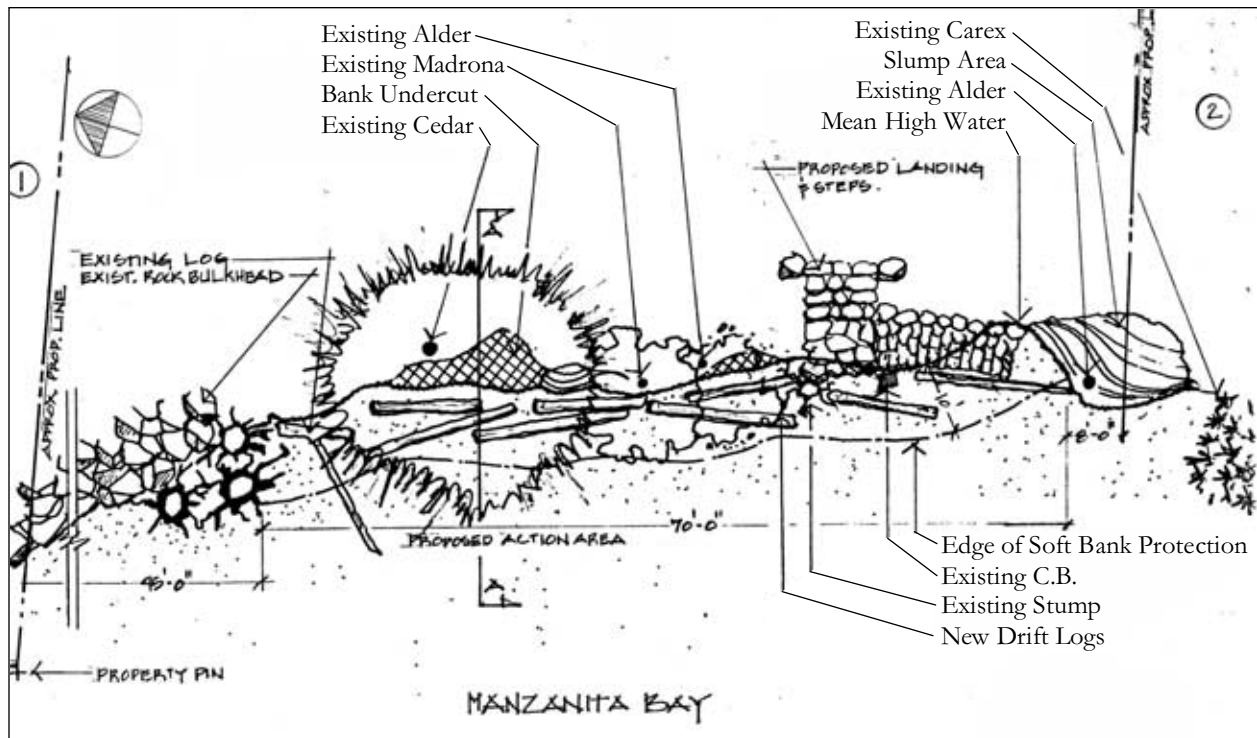
Dick Residence: Bird's Eye View of the Site.

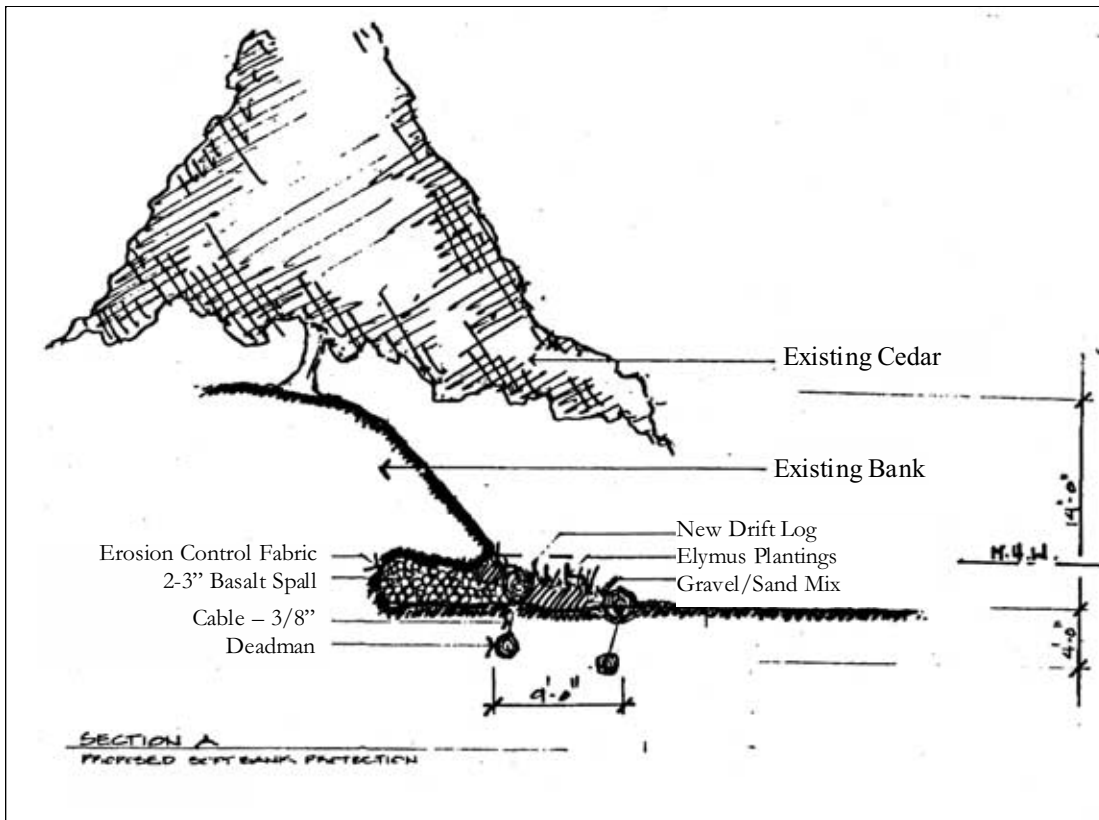
Dick Residence: Project Profile

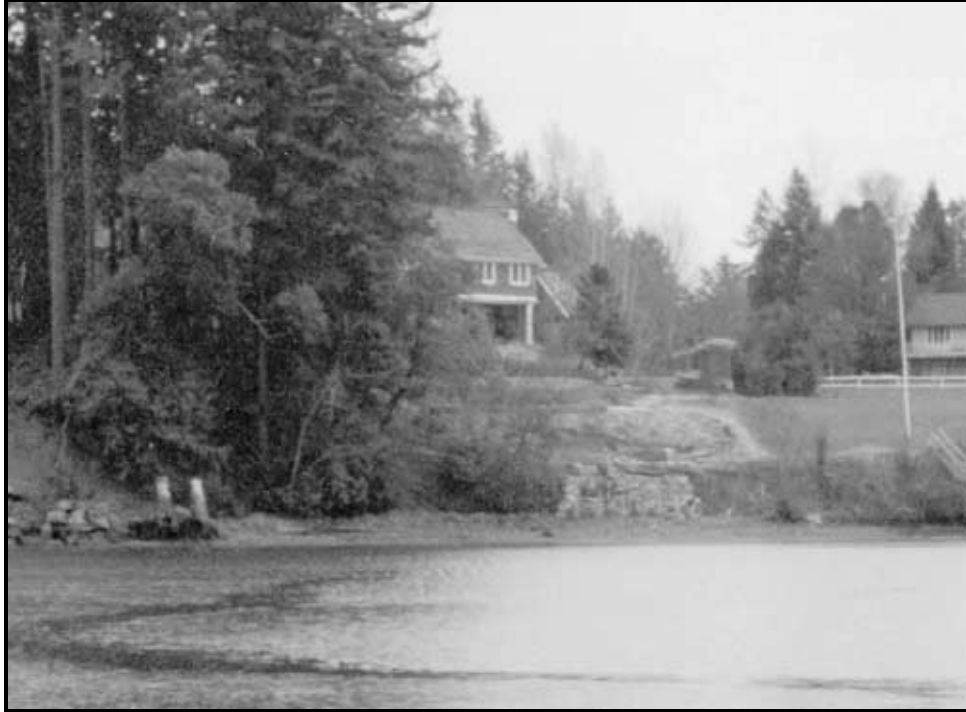
Figure 1. The Dick residence is sited well back from the water and trees north of the house were left. The riprap bulkhead on the north end of the site was installed by neighbors as an emergency measure prior to construction of the Dick's home (Photo: Jim Brennan).

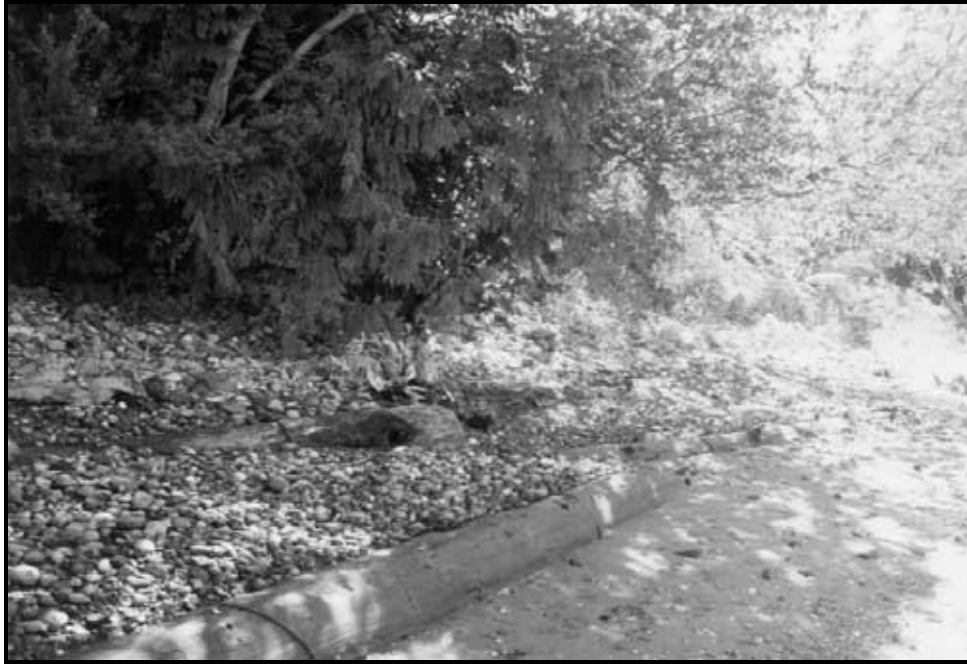
Figure 3. View southeast along beach shows anchored logs and added gravel. Compare to Figure 4 below of property to the north.

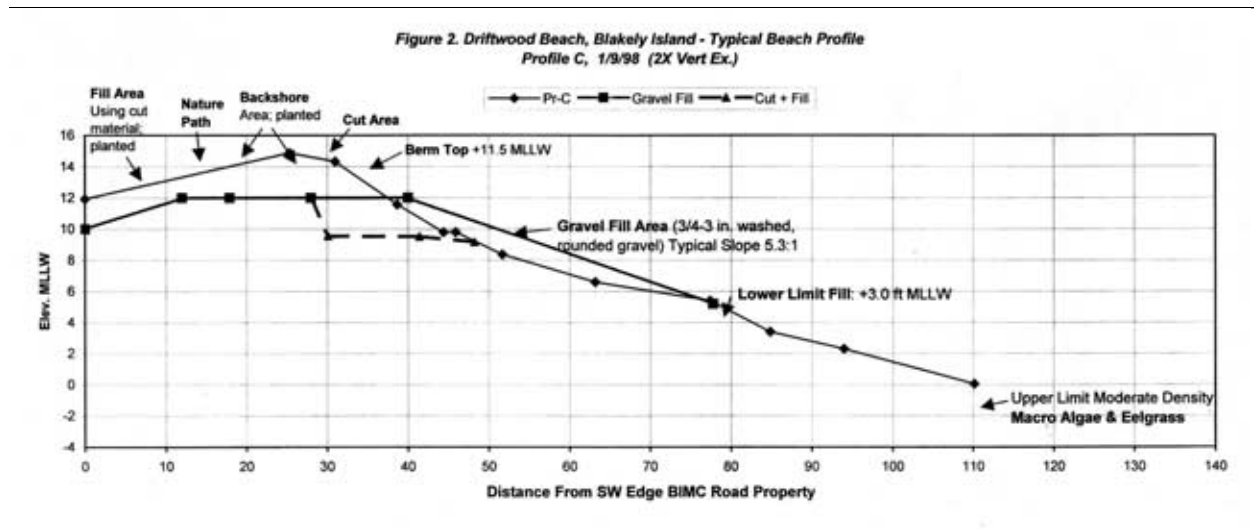
Profile for Transect C

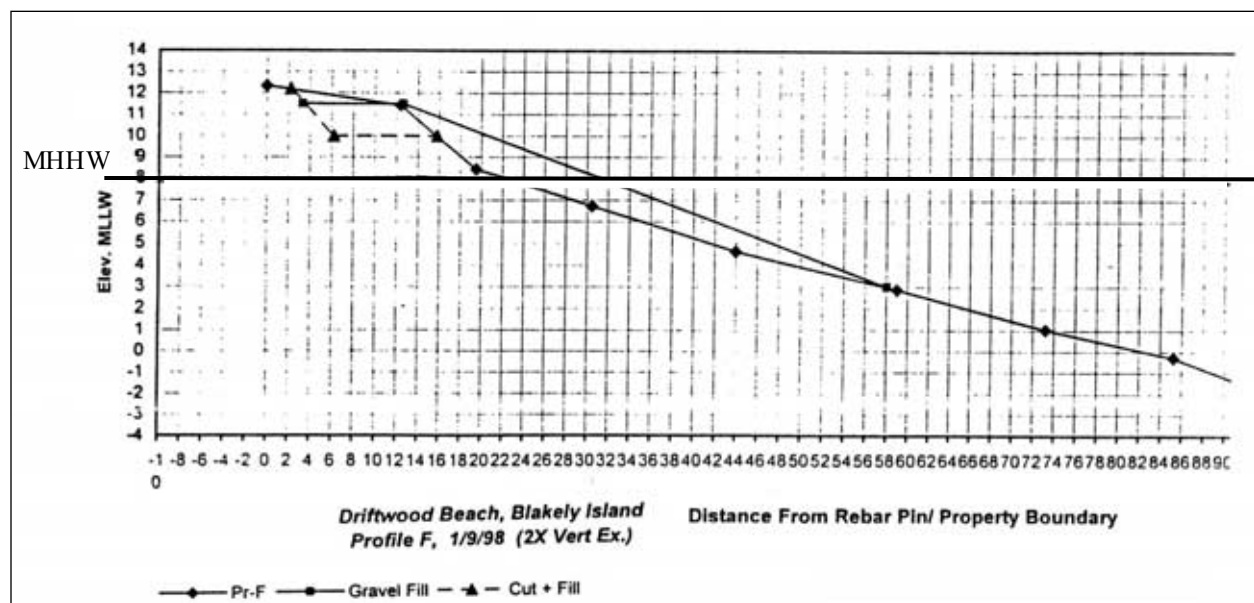
Profile for Transect F

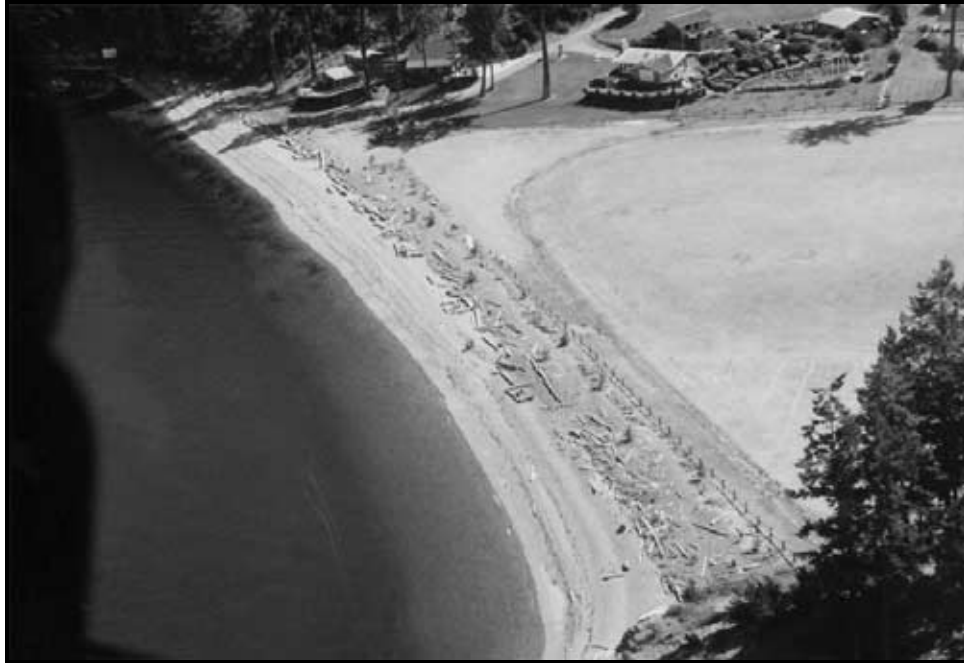
Figure 1. Aerial view of Driftwood Beach. Upland revegetation and restoration extends entire length of beach, whereas beach nourishment was limited to area indicated by arrows. Lawn area on right side of photo was marsh prior to filling several decades ago.

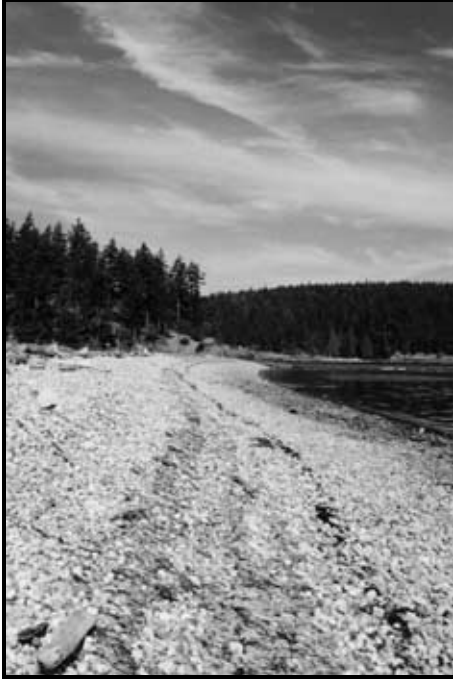
Figure 3. View north of completed gravel beach.

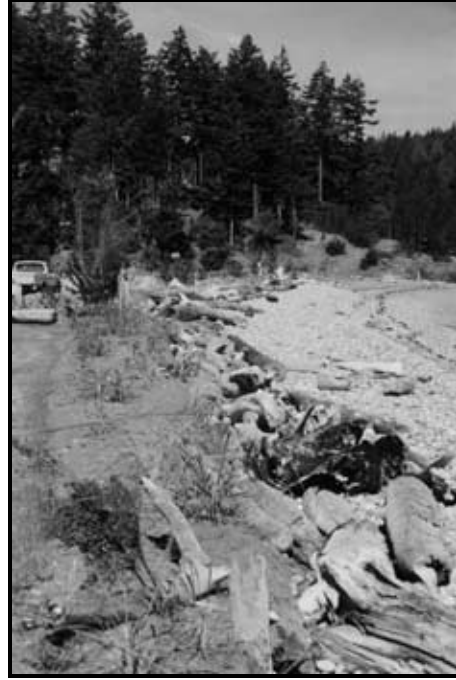
Figure 4. View north showing gravel berm, drift logs, and vegetated backshore. Road has been relocated landward.

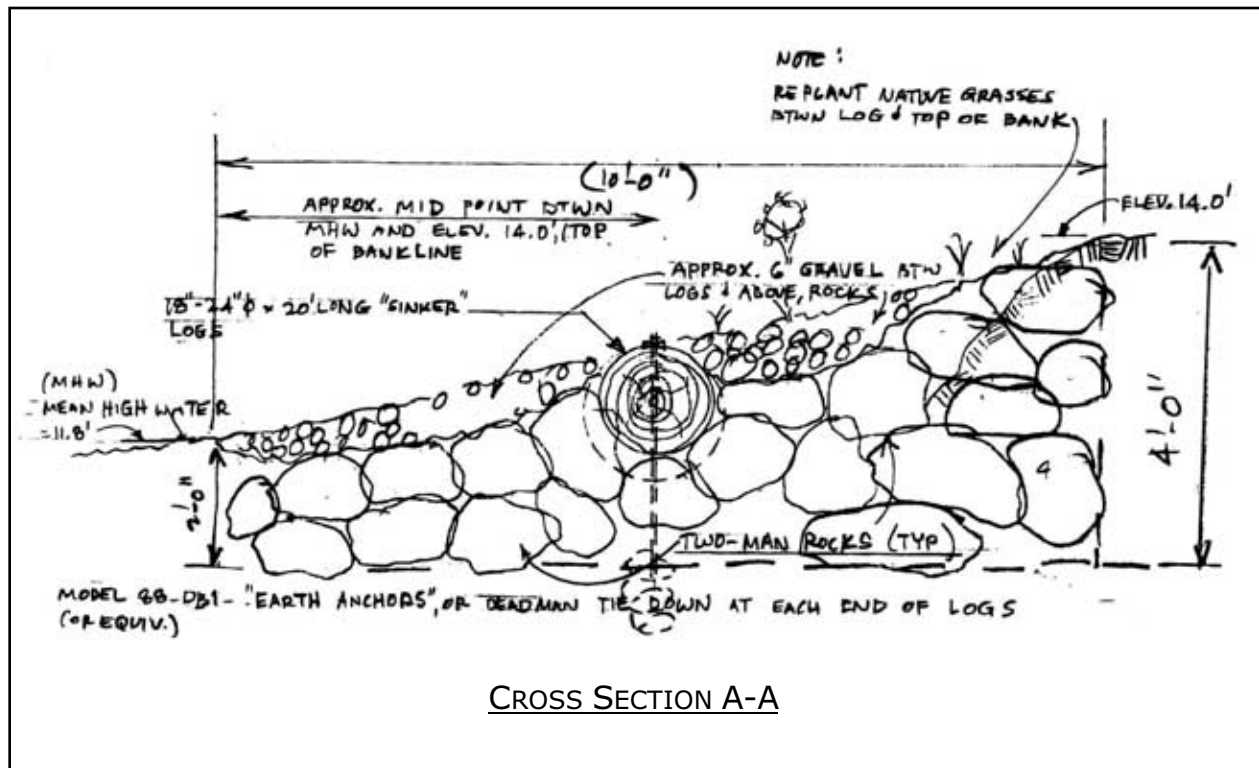
Dully Residence

The project was composed of three basic steps. 1) A wide trench was cut into the beach for placement of a buried rock revetment; 2) logs were anchored; and 3) the backshore was replanted with native beach grasses.

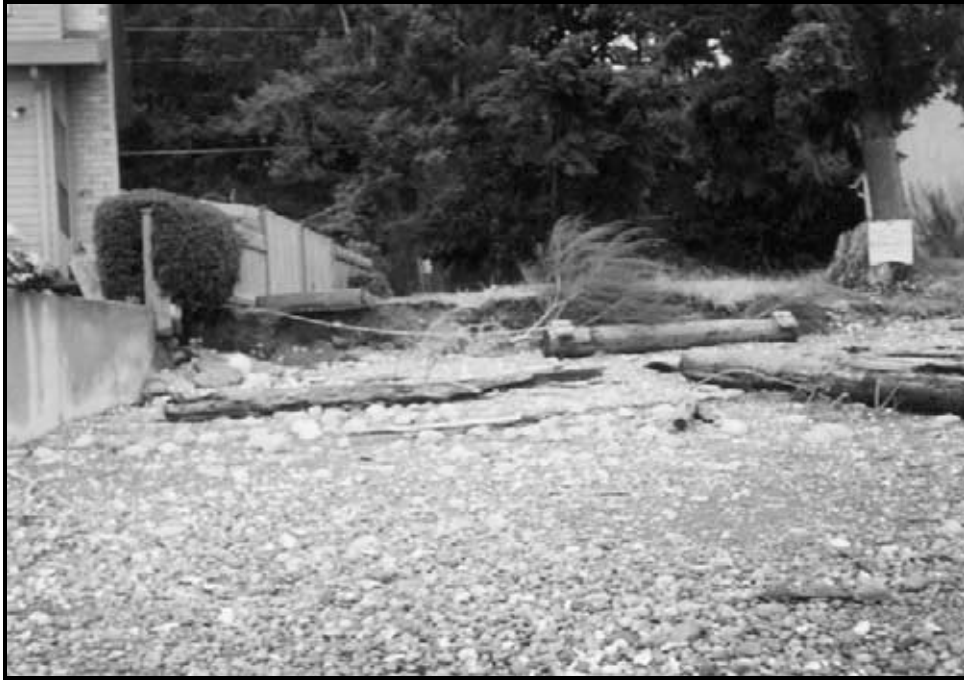
Figure 1. West end of site prior to construction. Note significant scarping and the amount of the neighboring bulkhead's wing wall that is exposed.

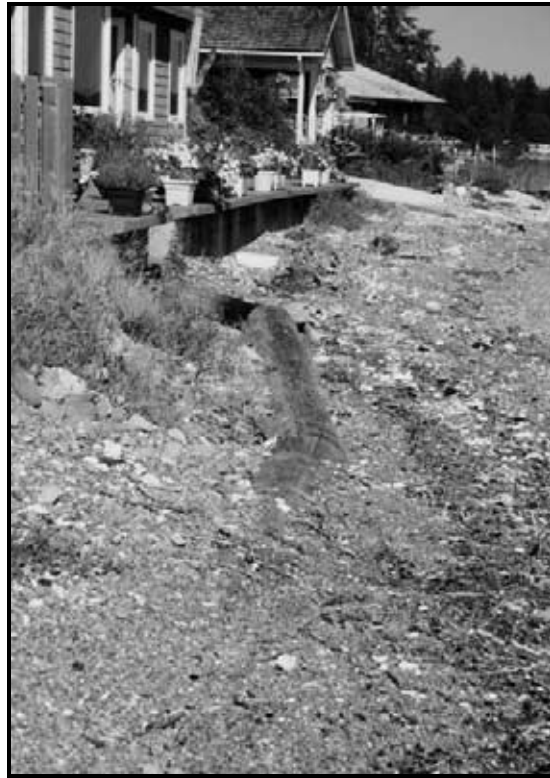
Figure 3. View of east end of site following completion of project. The logs rise out of beach and curve back to meet neighbor's bulkhead.

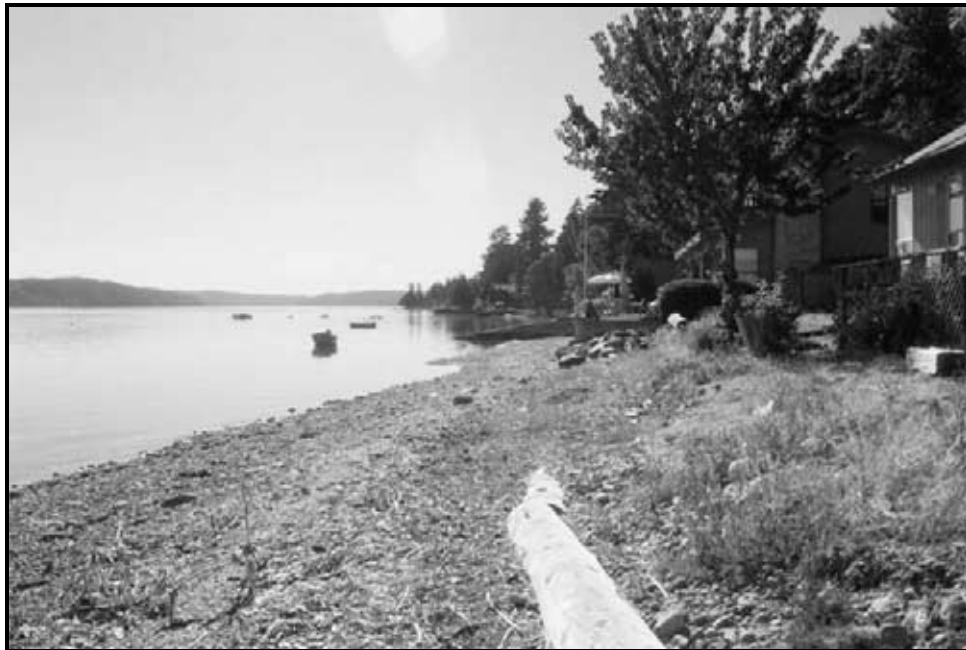
Figure 4. View of site from the west. Logs have been covered by accretion along much of beach. The logs reemerge at the far (west) end where a pile of rock reduces the impacts of the neighboring bulkhead.

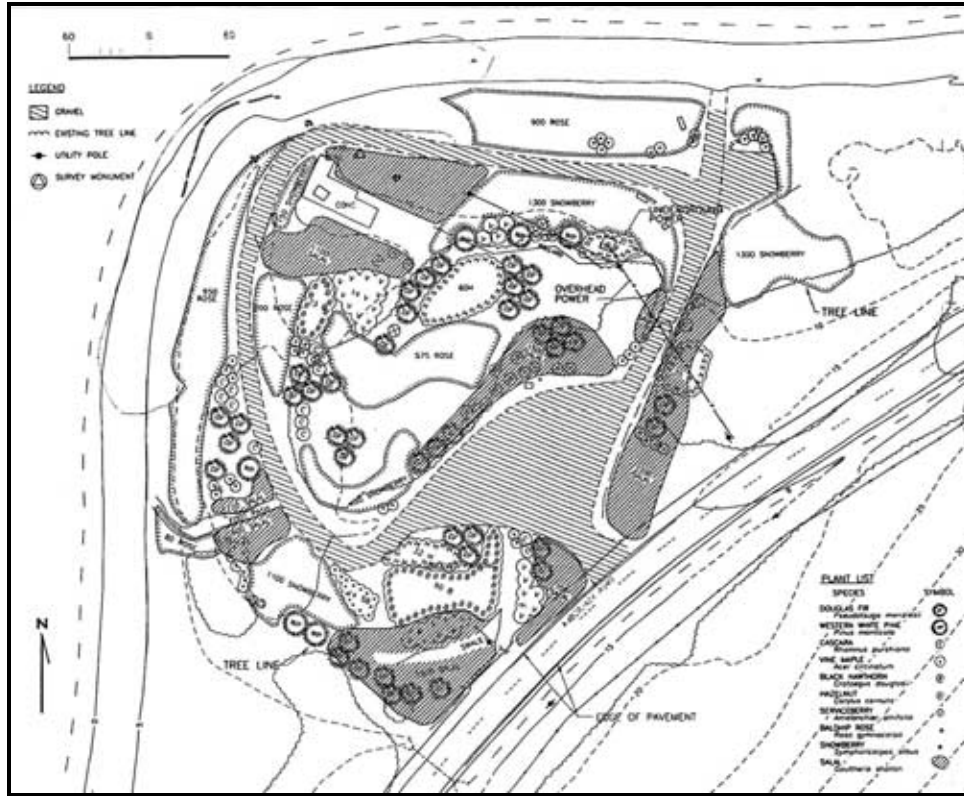
Floral Point: Planting Diagram

The purpose of the upland fill was to cap the contaminated soils to prevent any possible future contact with the hazardous material and create a marsh habitat. A one-foot thick cap was built over the former landfill. It consisted of a 2832 yd<sup>3</sup> of topsoil mix that was compacted in 4-inch layers. When the cap was in place, 200 yards of mulch were spread on the surface and 5100 plants were used to vegetate the berm and build a wetland area.

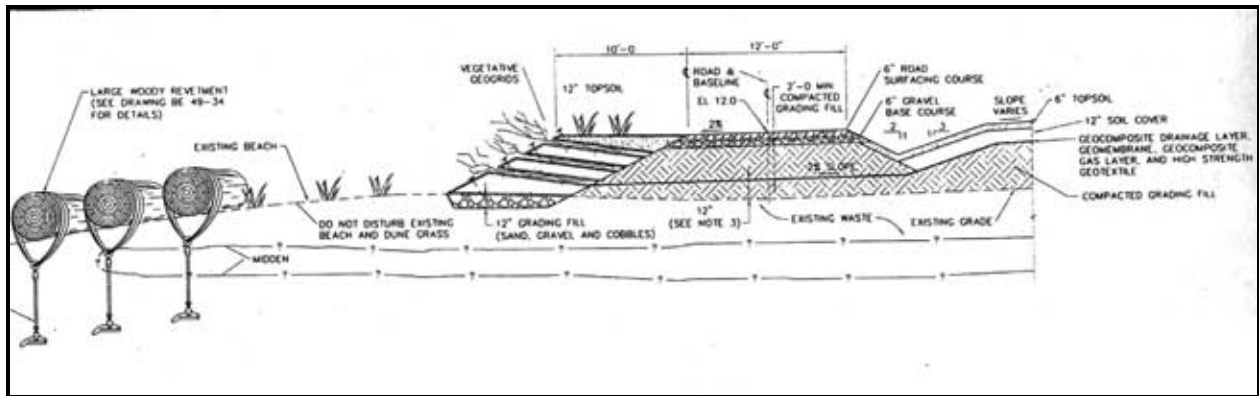
Low Energy Zone

**Low Energy:** In this section of beach large woody debris was substituted for rock. This follows the concept of softer protection for lower energy sites. The woody debris is secured to the beach with derivable anchors (no excavation necessary).

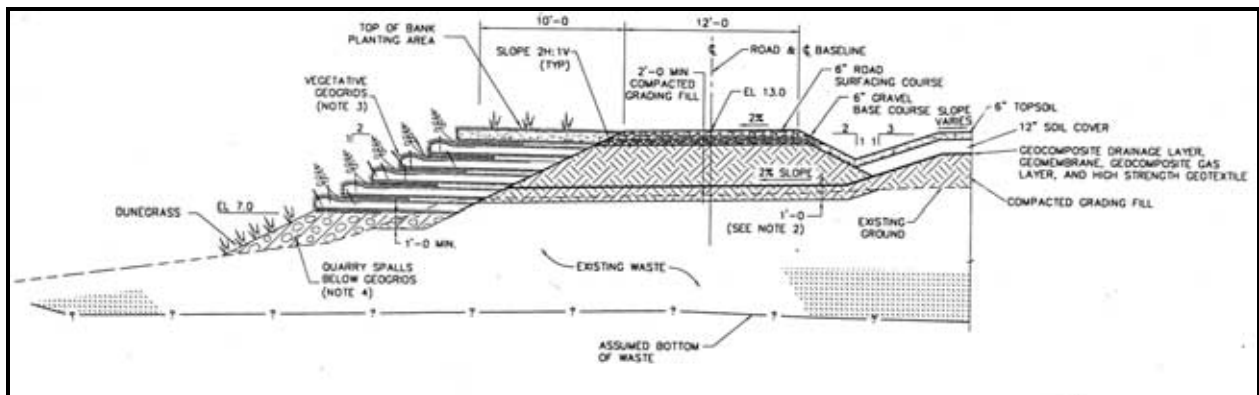
Very Low Energy Zone

**Very Low Energy:** The final section, adjacent to the tidal lagoon, is very similar to the low energy solution. It differs in that it uses a larger quarry spall toe and has reduced quantities of woody debris.

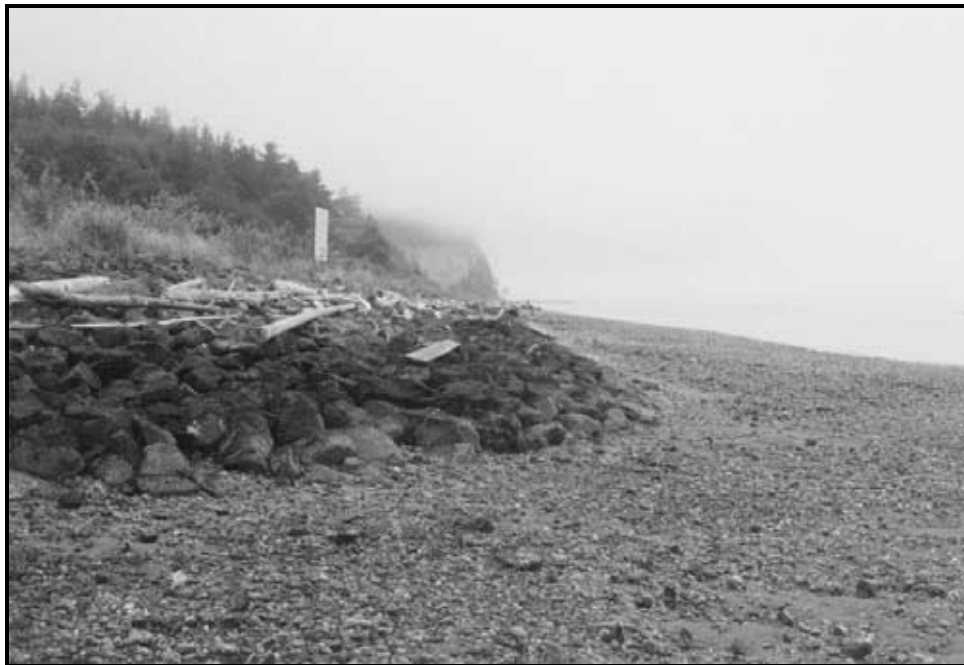
Photo 2. View southwest from northern end of project. A rock revetment is used in the high energy zone.

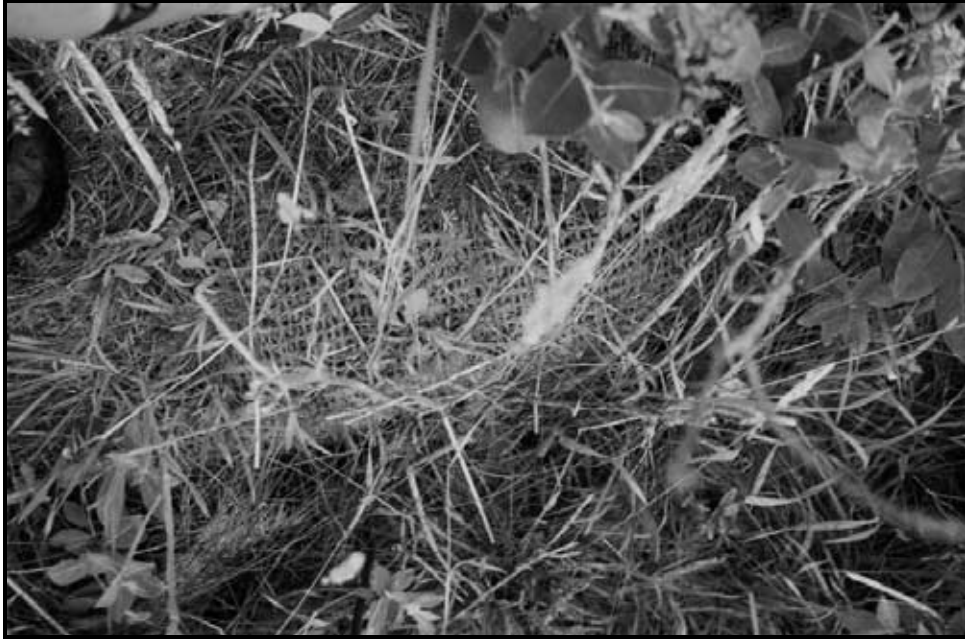
Figure 5. Natural fiber geotextile. Coir fabric is exposed on the face of a geogrid lift.

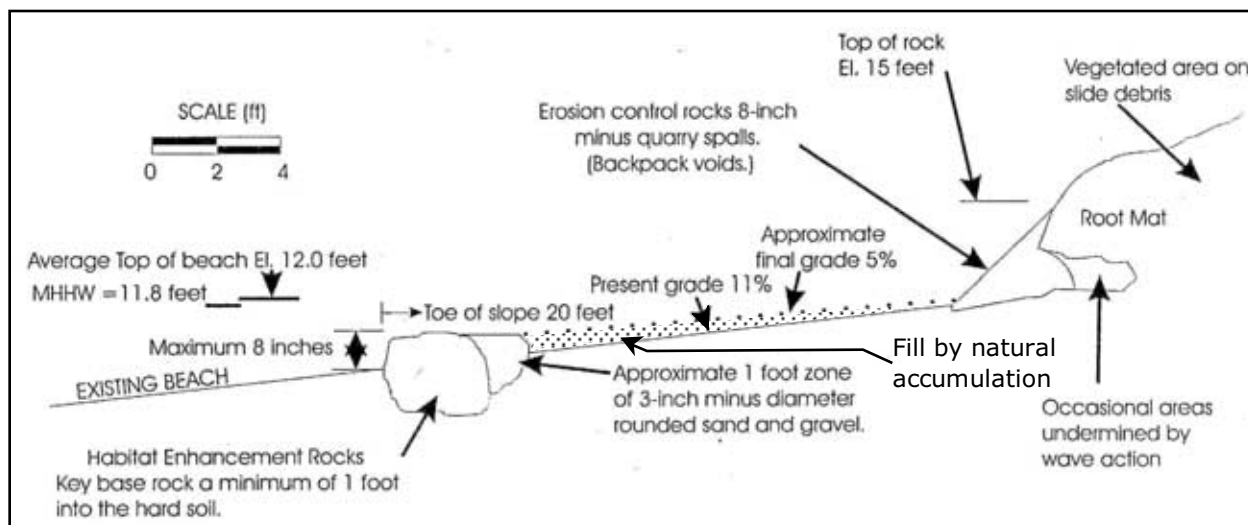
Profile: West end of the site – toe protection and habitat enhancement rocks

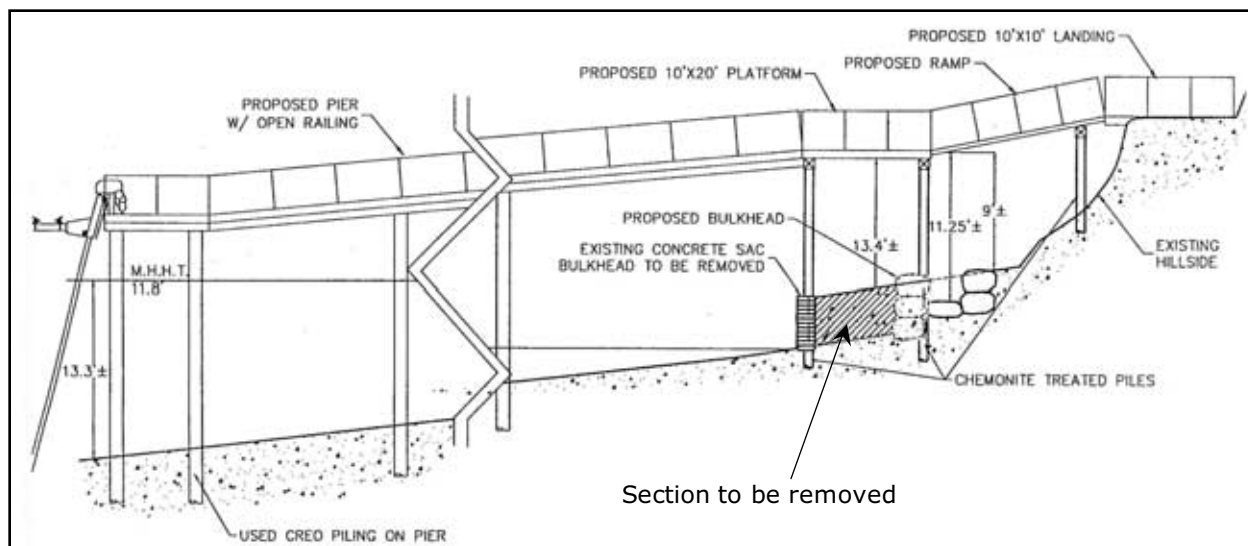
Profile: Central section – removal of existing bulkhead and fill as mitigation

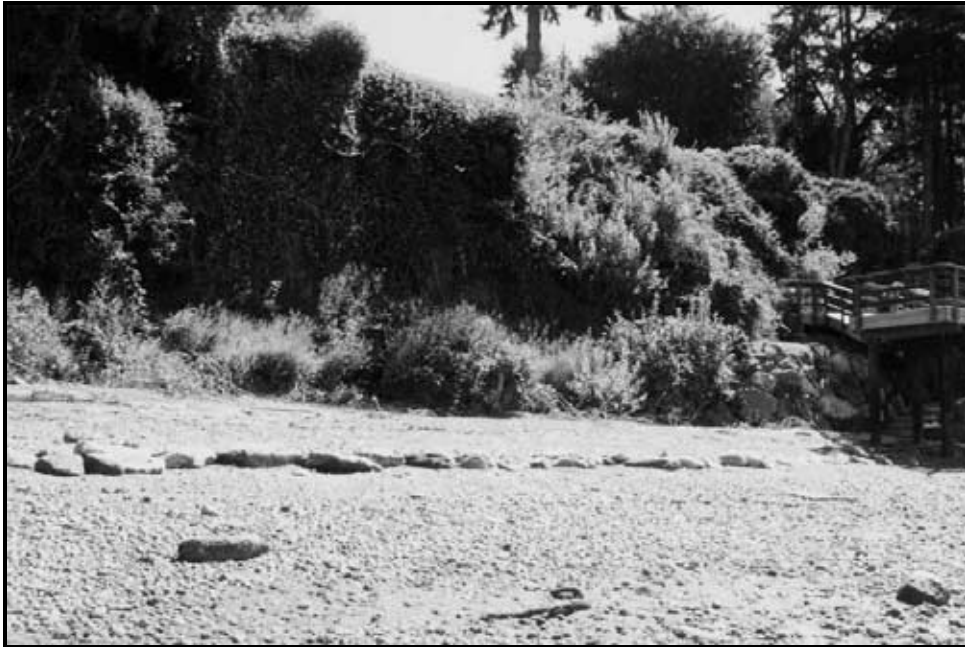
Figure 1. View of Odermat site showing bluff, base of pier, and row of rocks buried in the beach.
