# Alternative Bank Protection Methods for Puget Sound Shorelines

# **Alternative Bank Protection Methods for Puget Sound Shorelines**

Shorelands and Environmental Assistance Program  
Washington Department of Ecology  
Olympia, Washington

Publication # 00-06-012

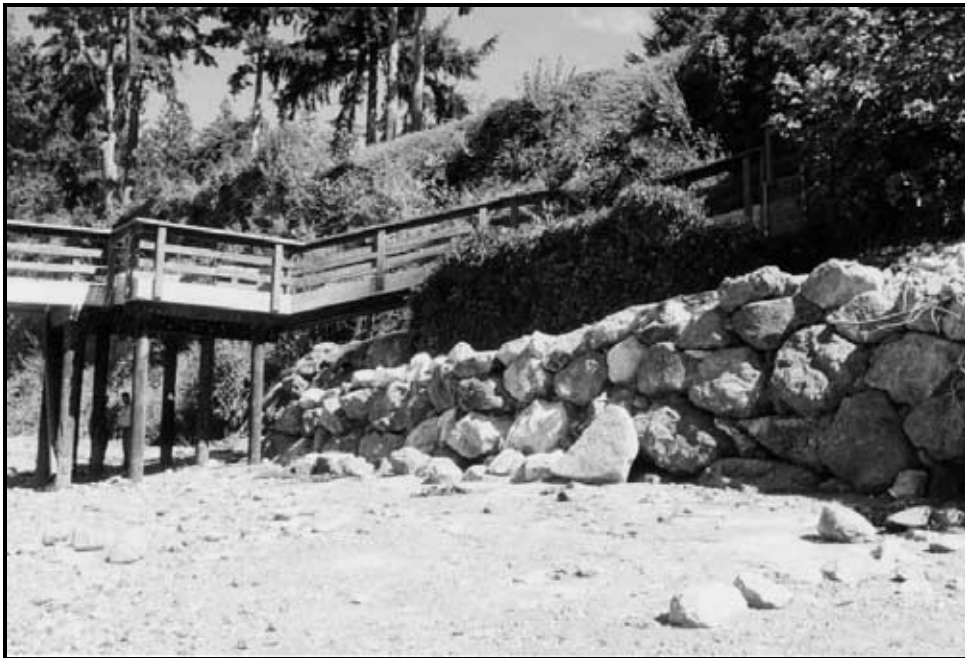
Figure 2. Rock bulkhead constructed on shore south of pier.

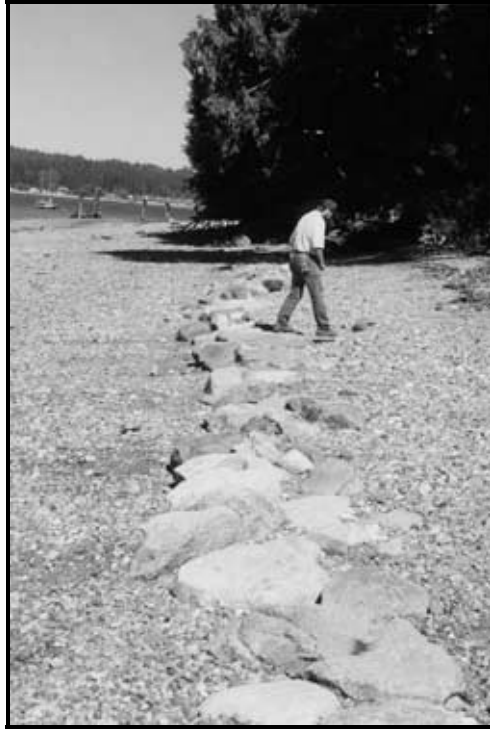
Figure 3. This row of boulders was placed to help stabilize upper portion of gravel beach.

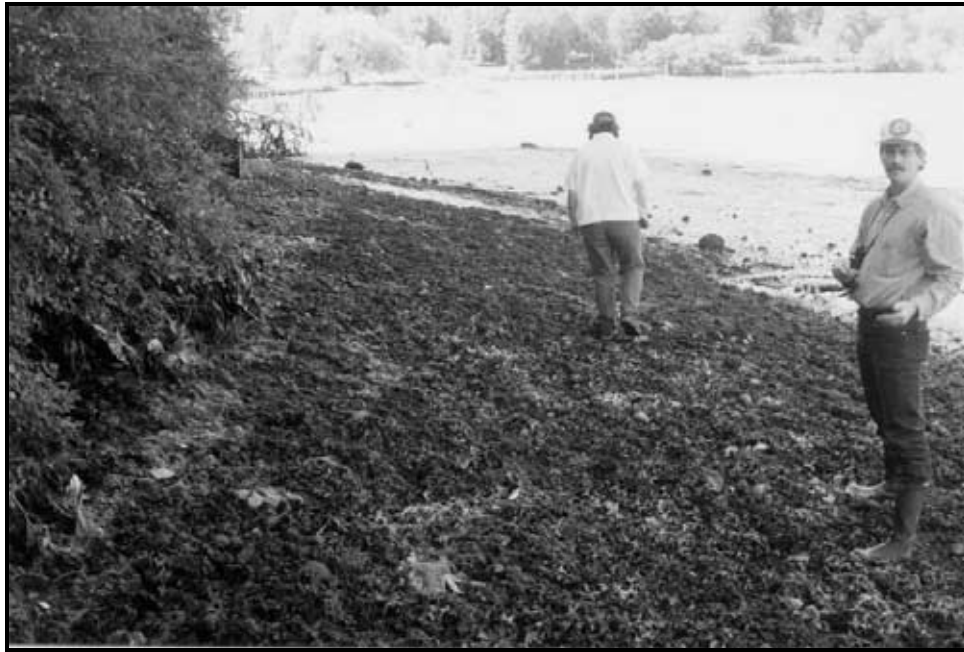
Figure 1. Gravel beach and vegetated bank. Quarry spall was placed at the toe of the slope and is largely covered with gravel. Aquatic vegetation is colonizing the coarse gravel, which is relatively stable in this low energy environment.

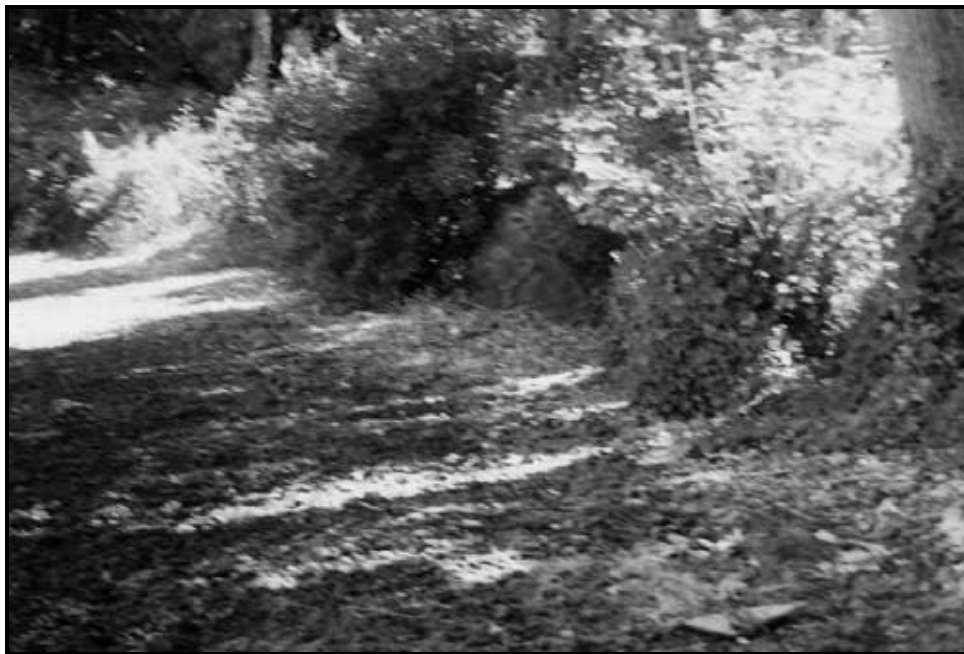
Figure 2. View of central portion of site, looking east. Note recent high tide line and wrack on gravel. By raising beach elevation, opportunities for waves to erode the toe of the bank are greatly reduced.

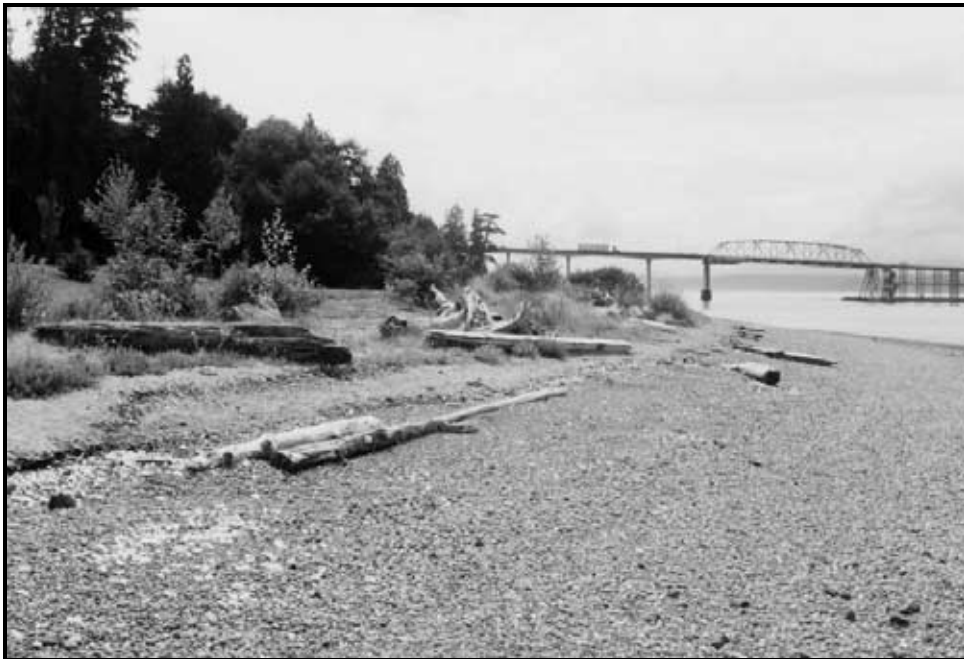
Figure 2. Second view to west, showing more of beach and Hood Canal Bridge in background (1999).

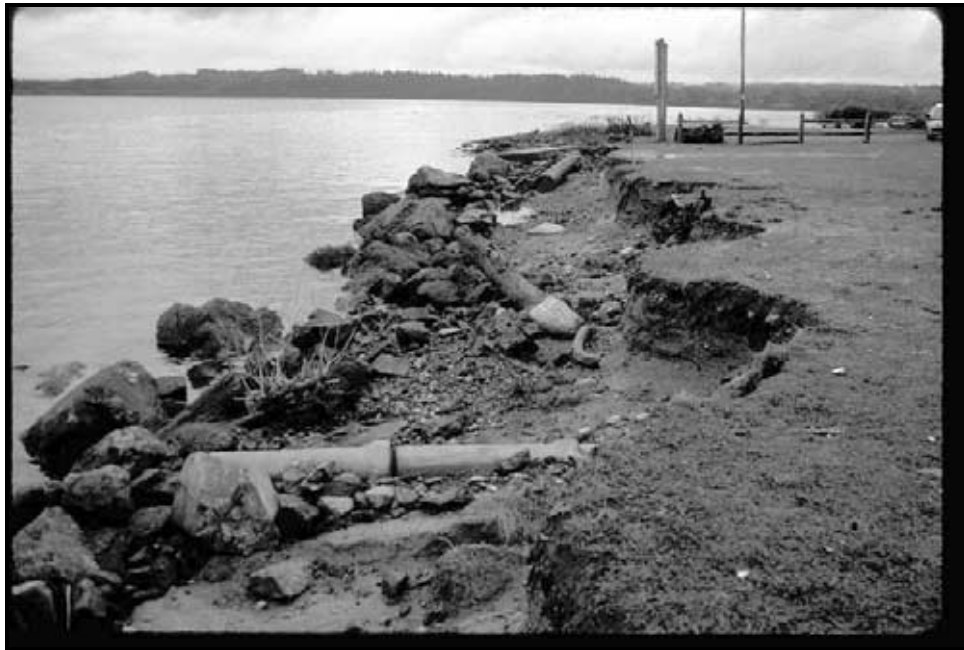
Figure 3. View east of project area prior to nourishment. Note scarp in eroding artificial fill and rocks placed in effort to reduce erosion (1995).

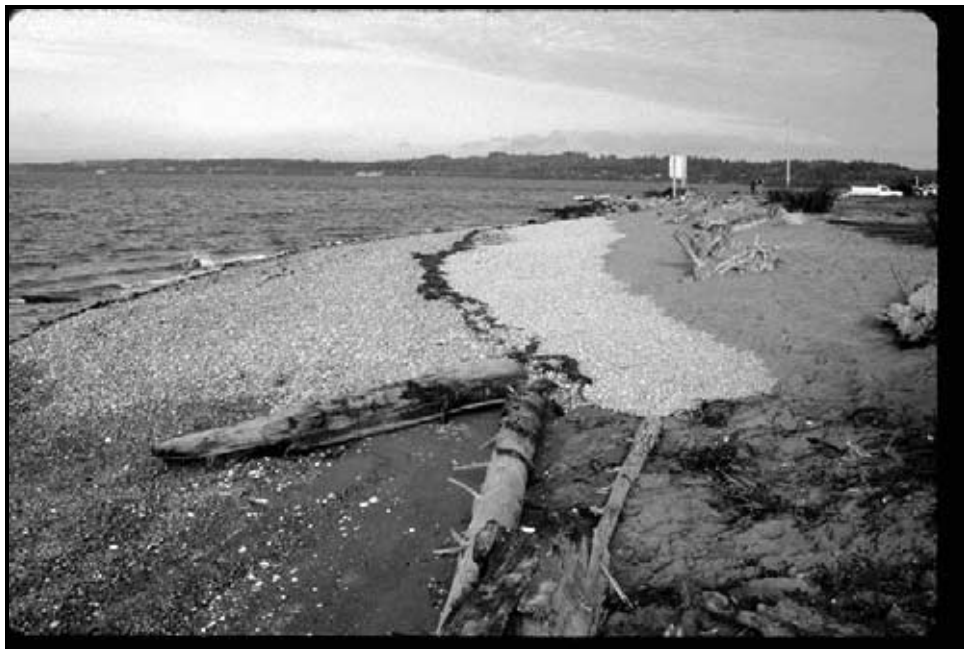
Figure 4. View to the east immediately following construction (Fall, 1995), showing gravel beach and recent high tide line. Note sand placed on landward portion of the berm.

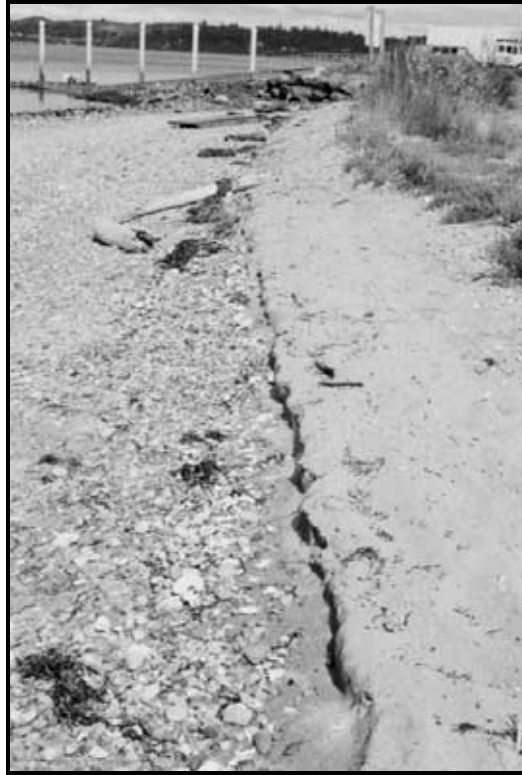
Figure 5. 1999 photo shows an erosional scarp in sandy berm. This sand was deposited during the winter of 1998-1999 by movement of drift from the south and was gradually eroded by summer wave action from the north. This illustrates natural variability common to both natural and nourished beaches.

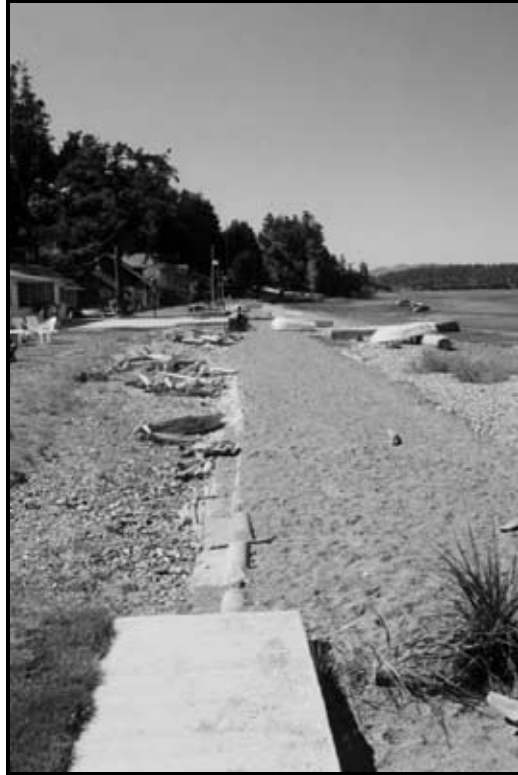
Figure 3. View west along bulkhead line in central portion of project. The bulkhead in the foreground failed in the winter of 1996-1997 (see Figure 6). Note elevation of backshore and placement of sand to facilitate revegetation.

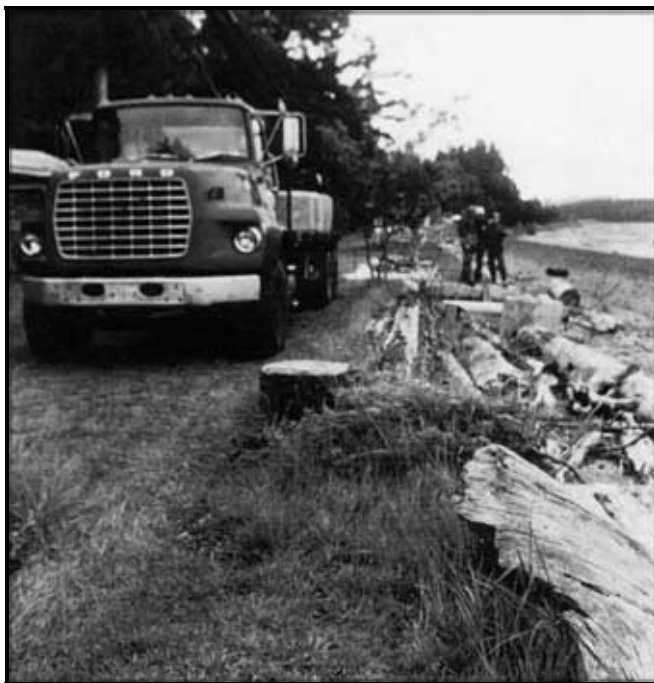
Figure 5. Photo taken immediately prior to bulkhead construction in 1982 along east-central portion of project site. Note line of drift logs and narrow berm  
(Photo: courtesy of Marge Dunnington)

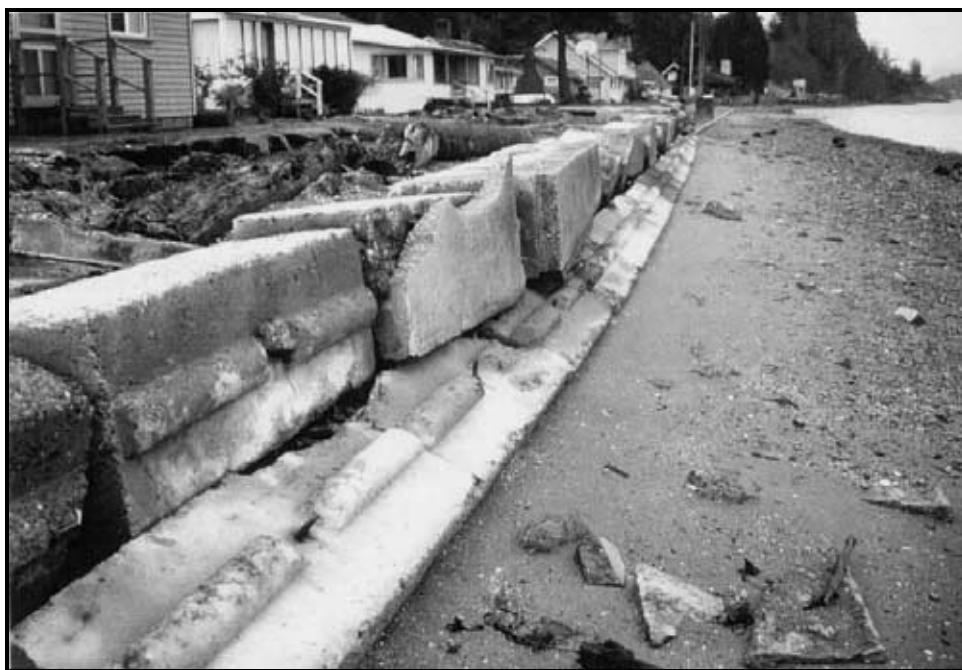
Figure 6. Ecology-block wall prior to nourishment. Failure occurred in the winter of 1996-1997 by undermining and excess hydrostatic pressure - upper tier has been restacked in this photo. Note erosion of upland area behind wall.

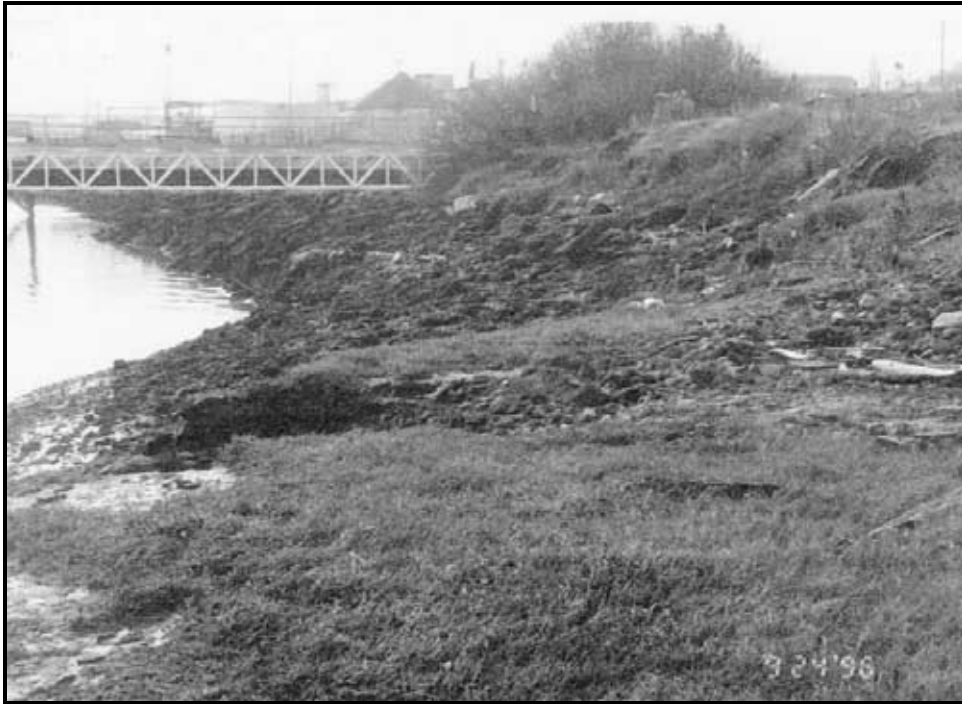
Figure 1. View south of site prior to construction. Note vegetated upper intertidal benches.

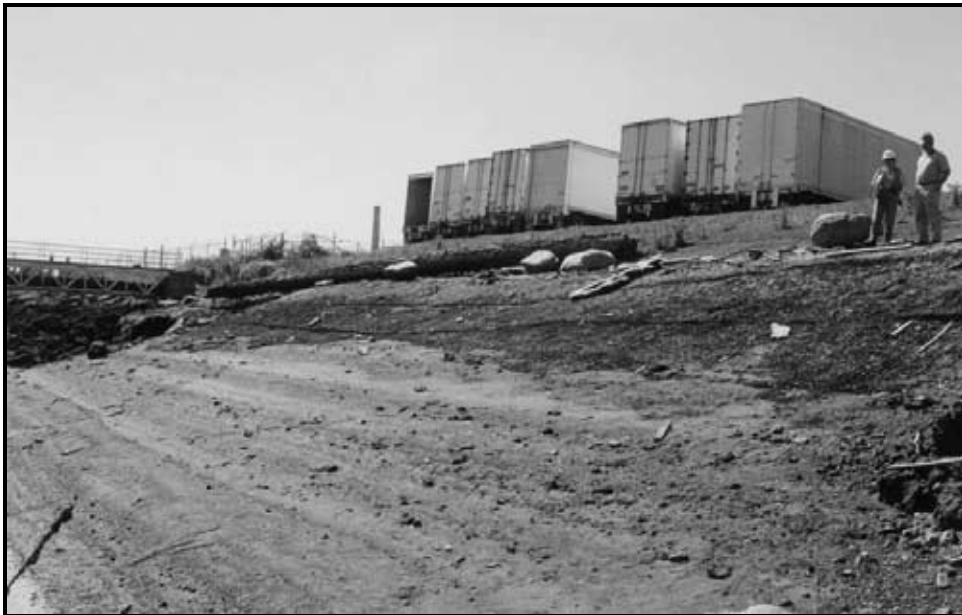
Figure 2. View southwest of site after construction. Fine sediment covers gabion mattresses except in area immediately below bench (people standing).

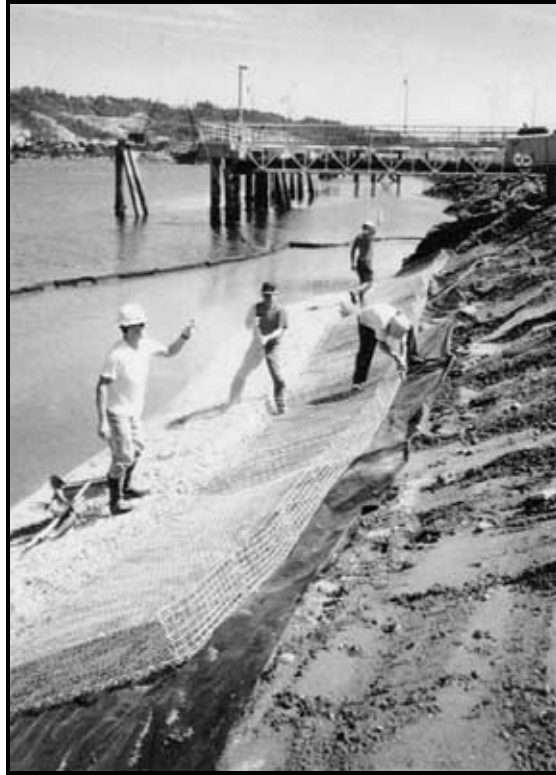
Figure 3. Installation of gabion mattresses over geotextile (*Photo: Joyce Mercuri*)

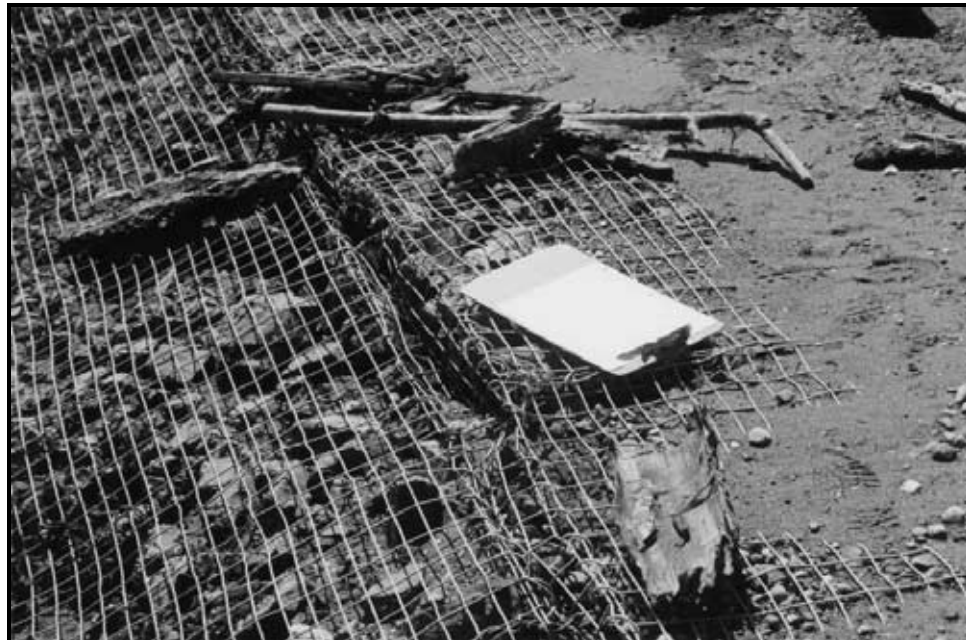
Figure 4. Detail at waterward edge of bench showing exposure of gabions.

The gabion baskets have been exposed on the waterward edge of the bench (Figure 4). This does not indicate any serious problem for the project, only that the intertidal slope may have been too steep. The geometry was constrained by the inflexibility in moving the shoreline landward and by space required by the bench itself.

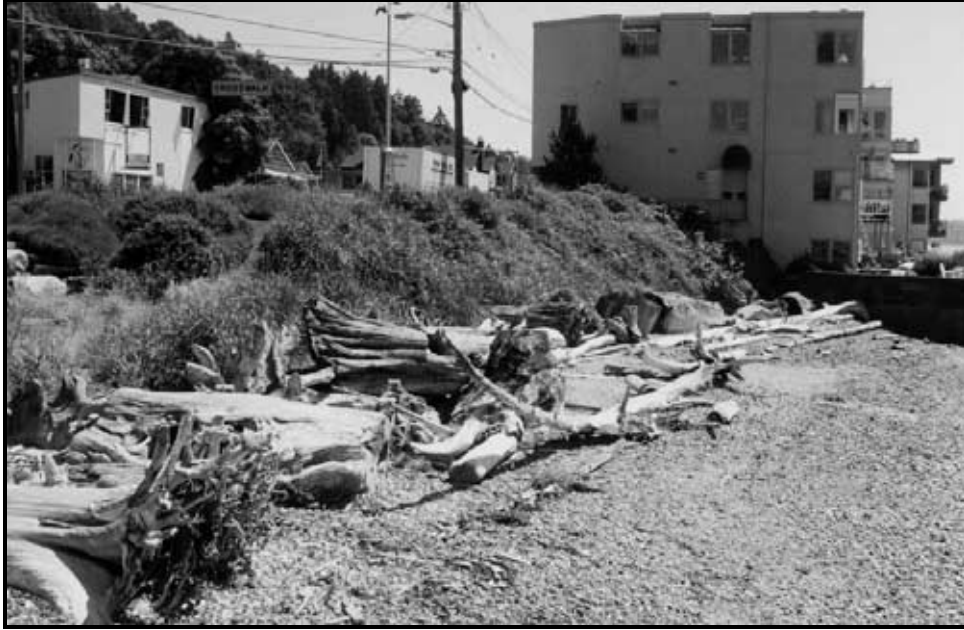
Figure 1. View south of Weather Watch Park. Note vegetated bank and drift accumulation along berm

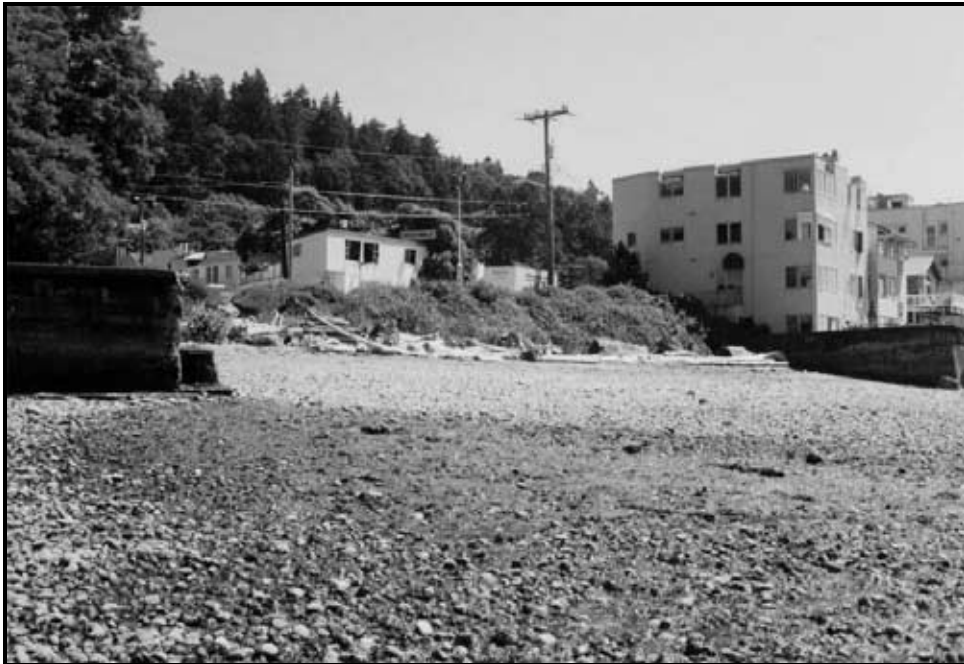
Figure 2. View of park illustrating adjacent bulkheads. This photo emphasizes why it is difficult to restore, or maintain, natural beaches when human action has encroached into the intertidal.

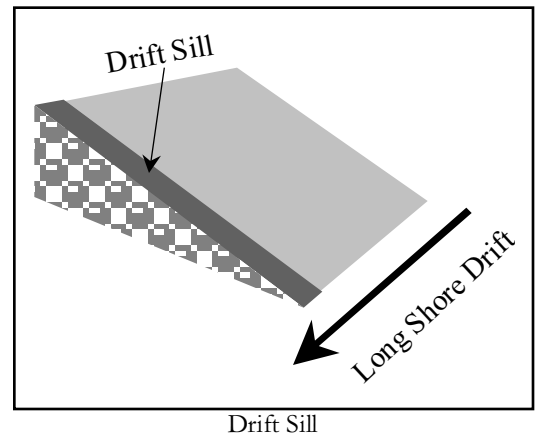
*Drift Sill* – A groin built level with the beach surface. Designed to allow bypassing of littoral sediment while maintaining a prescribed beach grade.

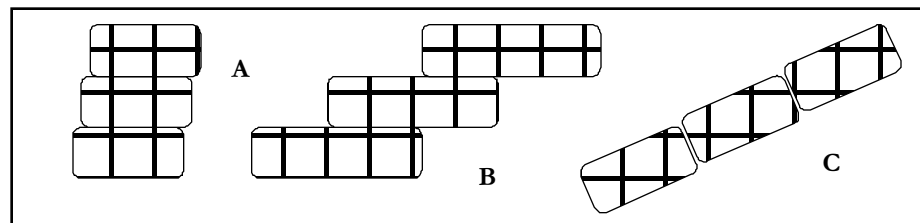
Gabions

*Gabion*: An erosion protection system that employs wire mesh baskets filled with rock to protect shorelines. These may be stacked to create a bulkhead (A), set up like the geogrid to create a stepped revetment (B) or laid flat to create a smooth slope (C).

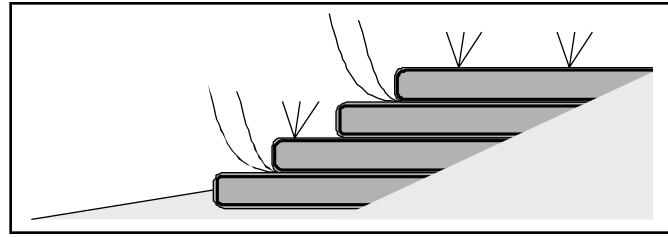
Geogrid

*Geogrid* – A bank stabilization system composed of multiple *geogrid lifts* and a planned vegetation system.

*Geogrid lift* – A layer of compacted soils wrapped in geotextile (usually a combination of both natural fiber and plastics).

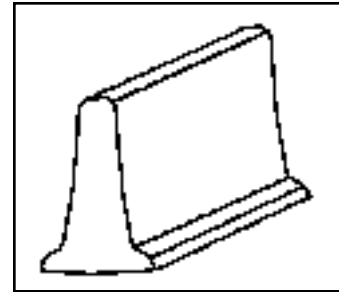
Jersey Barrier

*Jersey Barriers* – Sectional concrete barriers that often used in highway construction projects.
